STUDENT WHEELCHAIR TRANSPORTATION

- LOADING AND SECUREMENT -

Carl F. Stewart

October 1974

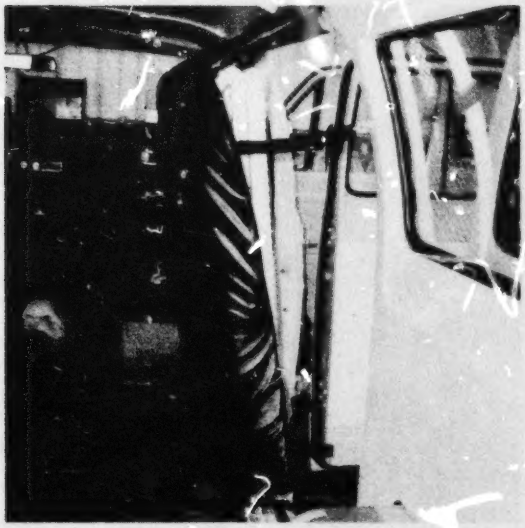
Side mounted ramps and lifts that store inside the vehicle are sharp hard objects that could be a hazard in an accident.

The padding shown in Figure 4 reduces this hazard. During

Inside Storage of Ramp - With Padding

loading and unloading, this pad is folded onto the roof of the vehicle so that it can protect the passenger's head from the sharp top edge of the door frame.

c. Loading equipment shall be provided with protective padding when it is exposed inside the vehicle;

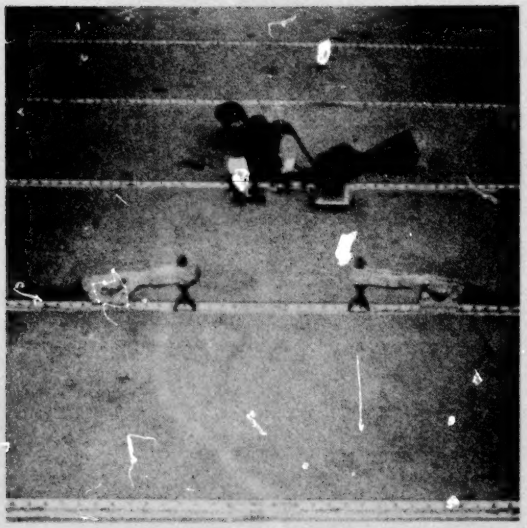
The rim clamp shown in Figure 5 provides a fast, simple and positive securement of the wheel rim. However, two clamps alone are not sufficient to prevent rotation of the chair about the rear axle. A third securement point--usually a strap--is used to prevent rotation. Mounting the rim clamp on the side wall reduces its suitability for chairs with varying wheel diameters.

Rim Clamps on Adjustable Track

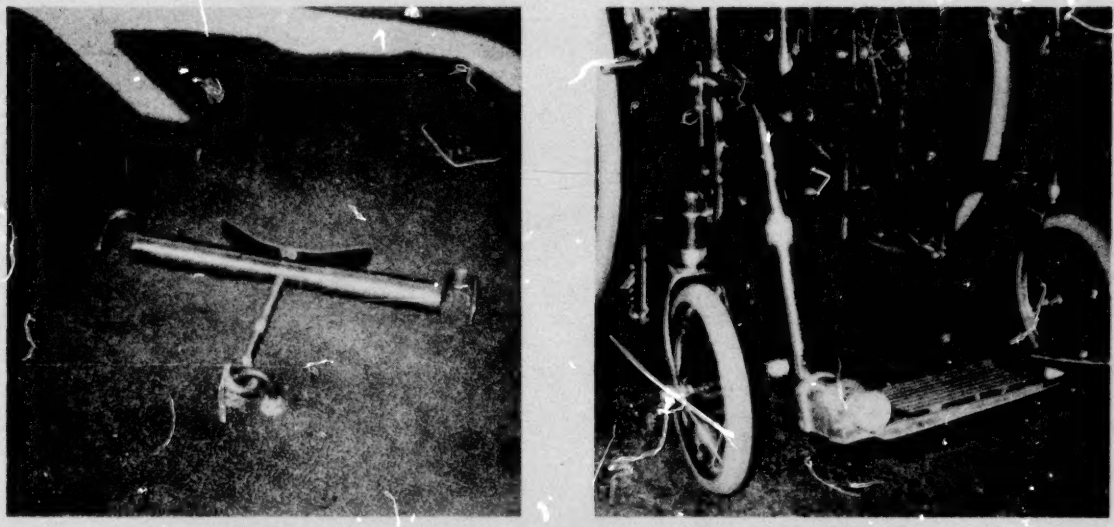
Figure 6

Many of the frame anchor devices do not physically connect to the wheelchair frame. They depend on clamping force to secure the chair. An example is shown in Figure 6. Should the chair wheels collapse, such devices can lose contact with the frame and no longer provide restraint. The extra loading exerted on them by the clamping force also increases the possibility of wheel failure, particularly if they are overtightened. The chain and S hocks system shown in Figure 7 pulls inward on the caster frame as the threaded rod is tightened. However, weight

"T" Bar Chair Securement

of the passenger on the chair during normal transit usually is sufficient to overcome this effect. On the other hand, should the bus overturn, such a device would tend to force the chair to close upon the passenger.

The possibility of chair rotation about its axis of securement was found in devices such as the T bar, and others with single attachment to the vehicle. Wheel friction on the vehicle floor and passenger securement to the vehicle are the only forces preventing this rotation. In addition, depending on the configuration of the chair frame, some T bar devices are capable, if not encouraged, to slide off of the sloping chair frame where it is attached (see Figure 6). Especially with heavy wheelchairs, the T bar and hooked clamp devices do not restrain longitudinal movement. It is therefore possible that a sudden stop or an accident could cause a passenger secured to the vehicle to sustain chair impact.

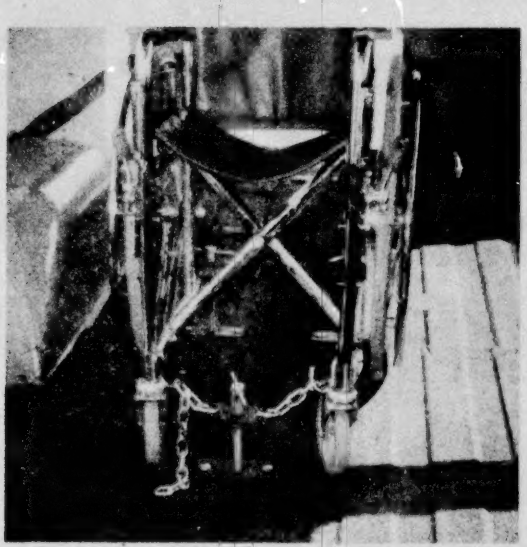
Figure 7

Chain and "S" Hook Chair Securement
